# Assessment and Feasibility Study for Uptowner Parking Garage

7th and Jackson Streets • Topeka, KS

December 1, 2021

**Photos – November 2, 2021**

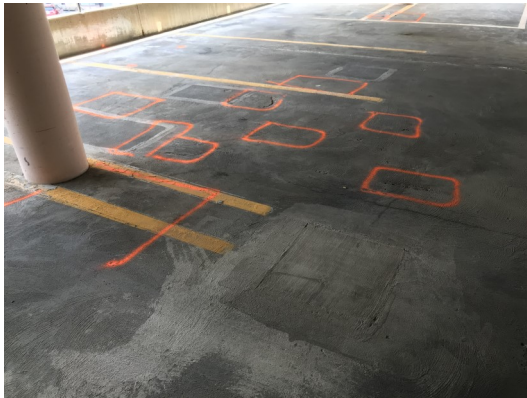
fig. 1

Results from sounding the parking decks indicated that approximately 9,150 s.f. of deteriorated or delaminated concrete is present (fig. 1). This represents about 9% of the parking surface. The levels showing the most deterioration were 7, 8, and 9. Approximately 410 s.f. of column (fig. 2) and wall (fig. 3) deterioration was noted. Overhead concrete deterioration of beam and joist soffits (fig. 4) was estimated at 400 s.f. On the 2/3 level original guardrails on top of the perimeter walls were removed such that a full height fence could be installed. The existing post were cut off flush with the top of the wall. The concrete in these areas is deteriorating (fig. 5).

To return this structure to a serviceable condition the deteriorated concrete should be repaired, and the structure should be waterproofed. The concrete should be repaired by removing all unsound concrete with 15 pound, maximum, chipping hammer in a manner that reinforcing steel is not damaged. Where 1/3 of reinforcing steel is exposed the concrete shall be removed all around it 3/4" clear. Areas shall be prepared by cutting or chipping edge a minimum of 1/4" deep such that no feathered edges exist, adding reinforcing steel at engineer's direction, and sandblasting areas clean (reinforcing free of rust). Areas to be patched back with SikaQuick-1000 for 2" horizontal repair, Sikacrete-1000 for full depth horizontal repair and SikaQuick-VOH for vertical and overhead repair. Patching back with Shotcrete is also acceptable. Areas to be patched back with shotcrete shall be with Spec Mix Dry Process Shotcrete with minimum 7 day strength of 5000 psi and 28 day compressive strength of 6000 psi. Mix shall contain polyester fibers of random length. To protect the parking deck from future salt and moisture infiltration we recommend installing a waterproofing traffic membrane system. After the concrete has been repaired a new membrane should be applied. The parking deck shall be primed with Sikalastic Primer. A base coat of Sikalastic-720 Base shall be applied. The parking areas shall receive a topcoat of Sikalastic-745AL. The drive lanes shall receive an intermediate coat and top coat of Sikalastic-745AL. The ramps from the 1<sup>st</sup> level to the 2<sup>nd</sup> level and to the basement shall receive Sikalastic 22 Lo-Mod Hybrid Traffic System with Black Beauty aggregate. The traffic coating system will be required to be provided with a five year joint and several warranty. It is very important that this work, concrete repair and membrane application, be done by a contractor that specializes in this type of work, if not the work will have a short life span.

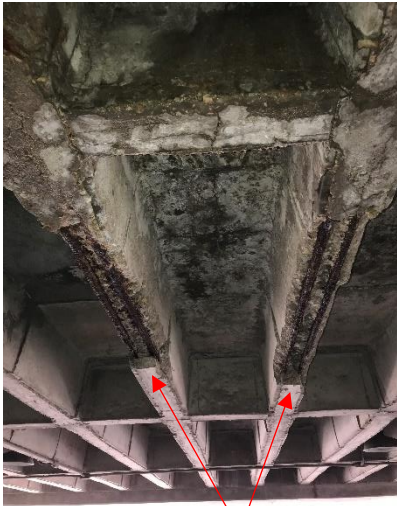
Deteriorating concrete  
and reinforcing steel  
joint stem

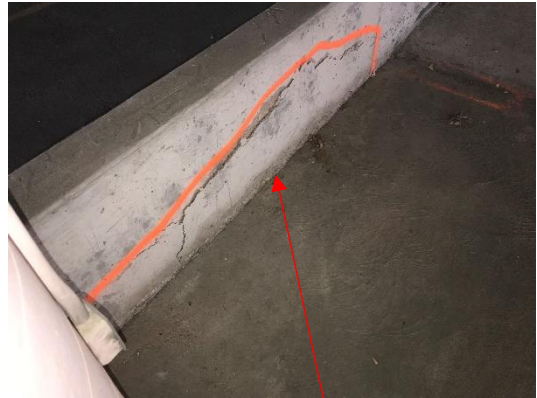
Spalled face of concrete wall

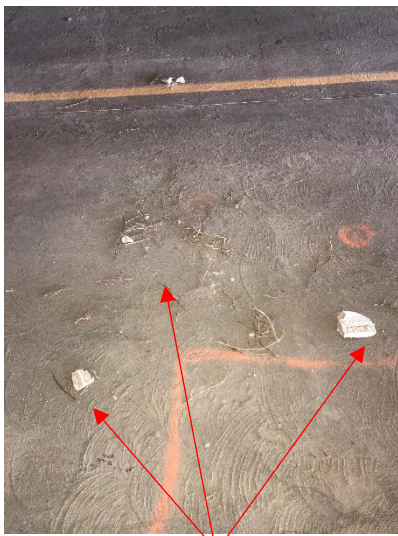
Debris on floor falling  
deteriorated concrete  
area above

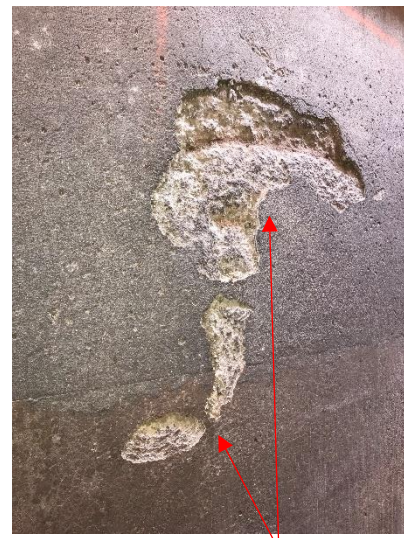
Spalled concrete slab

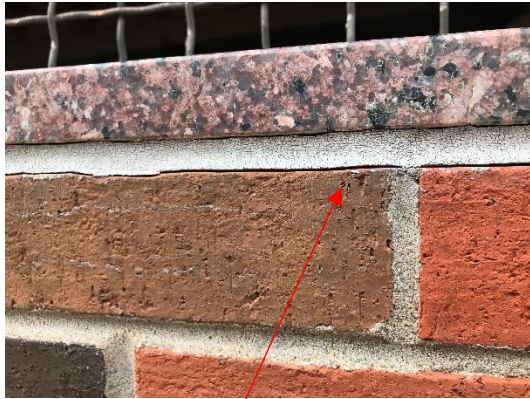
Failed sealant

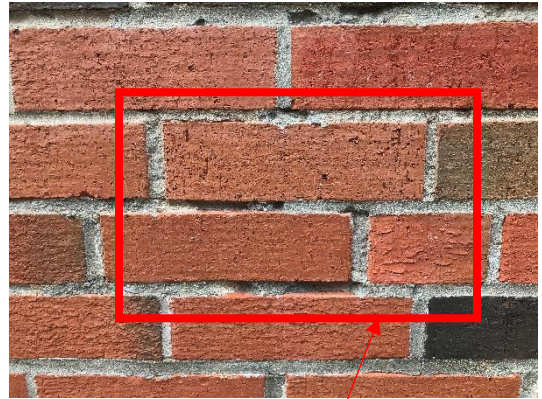
Open mortar joints  
require repointing

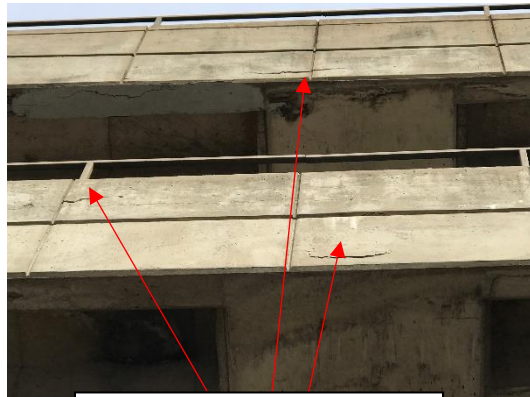
Spalled face of concrete  
spandrel beam

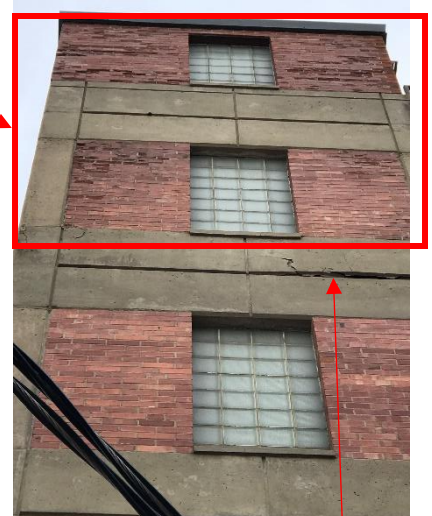
Spalled face of concrete spandrel beam.  
Spall should be removed for safety concerns

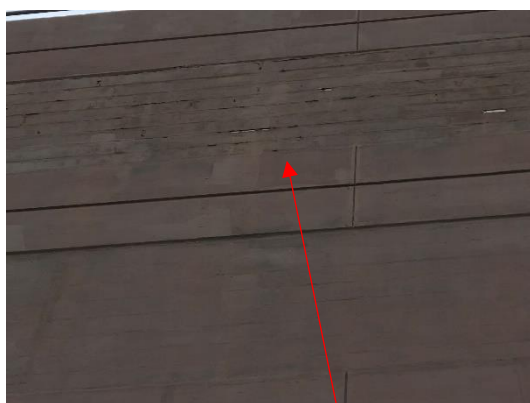
Spalled face of concrete  
spandrel beam

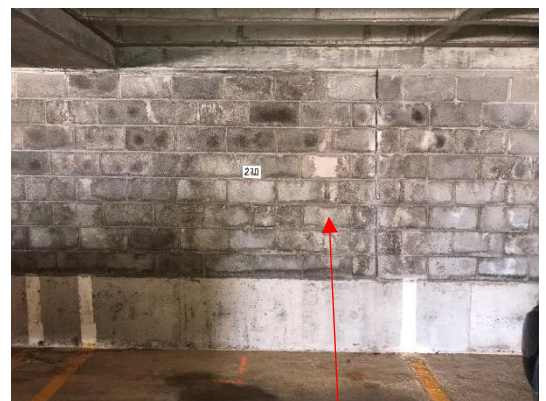
Moisture stains on the inside face of  
wall of failed elastomeric coating
