City-wide Sewer Cleaning and Closed-circuit Television Inspection Program

Data and Evidence Show the Path Forward

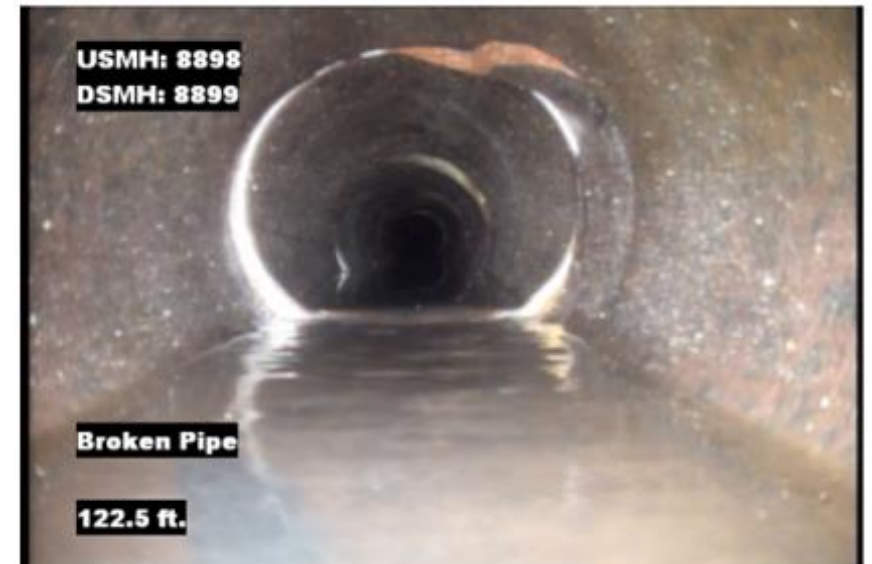
17935_5142019_B_122.5_U.jpg

Broken (B) - 122.50 ft.
Grade 4 - Facility ID 17935 - PRJ F7
% %
Clock to - 5 Clock from - 11

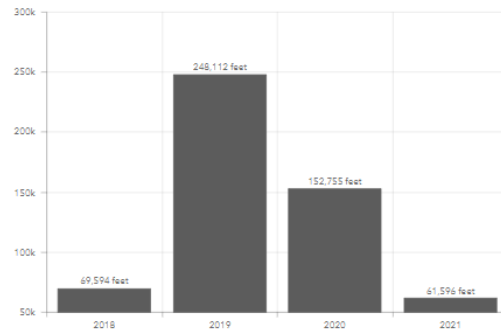
CCTV Inspected Pipe Footage by Year to Date

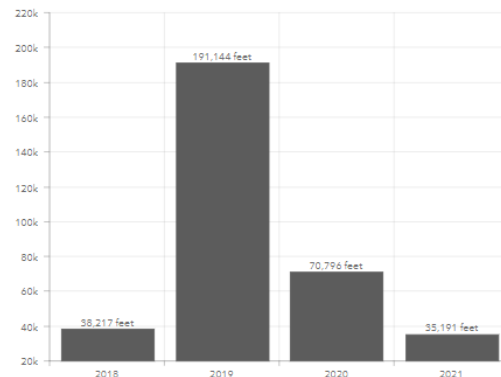
Pipes Cleaned by Year to Date

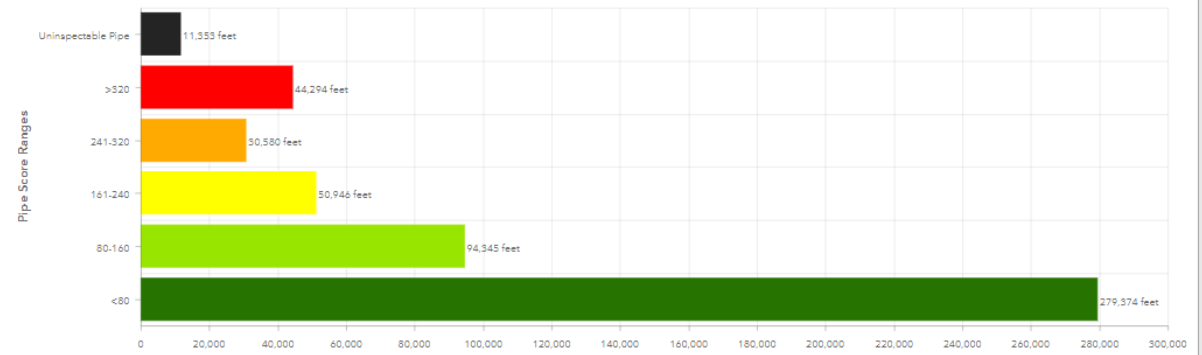
510,893 ft.
 Analyzed Pipe Footage

Scores by Footage of Analyzed Pipe

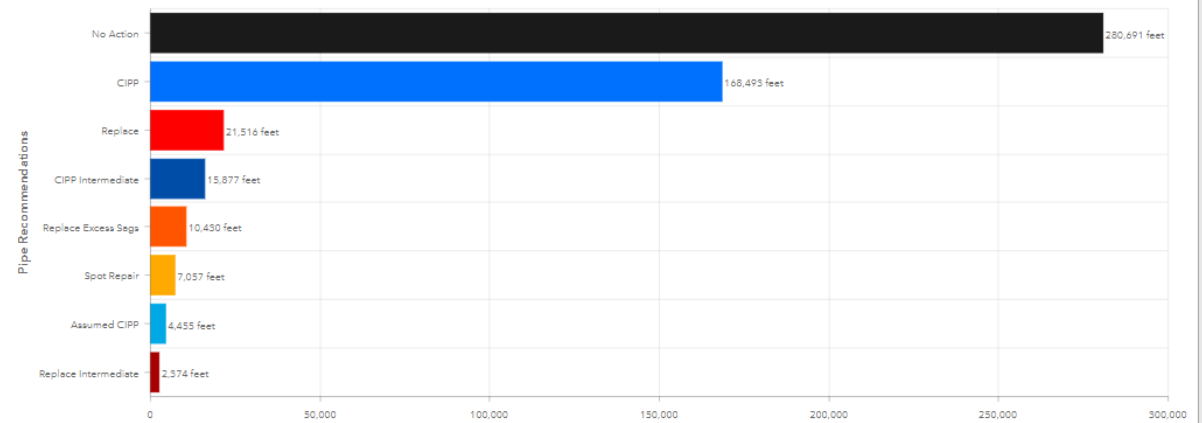
Recommendations by Footage of Analyzed Pipe

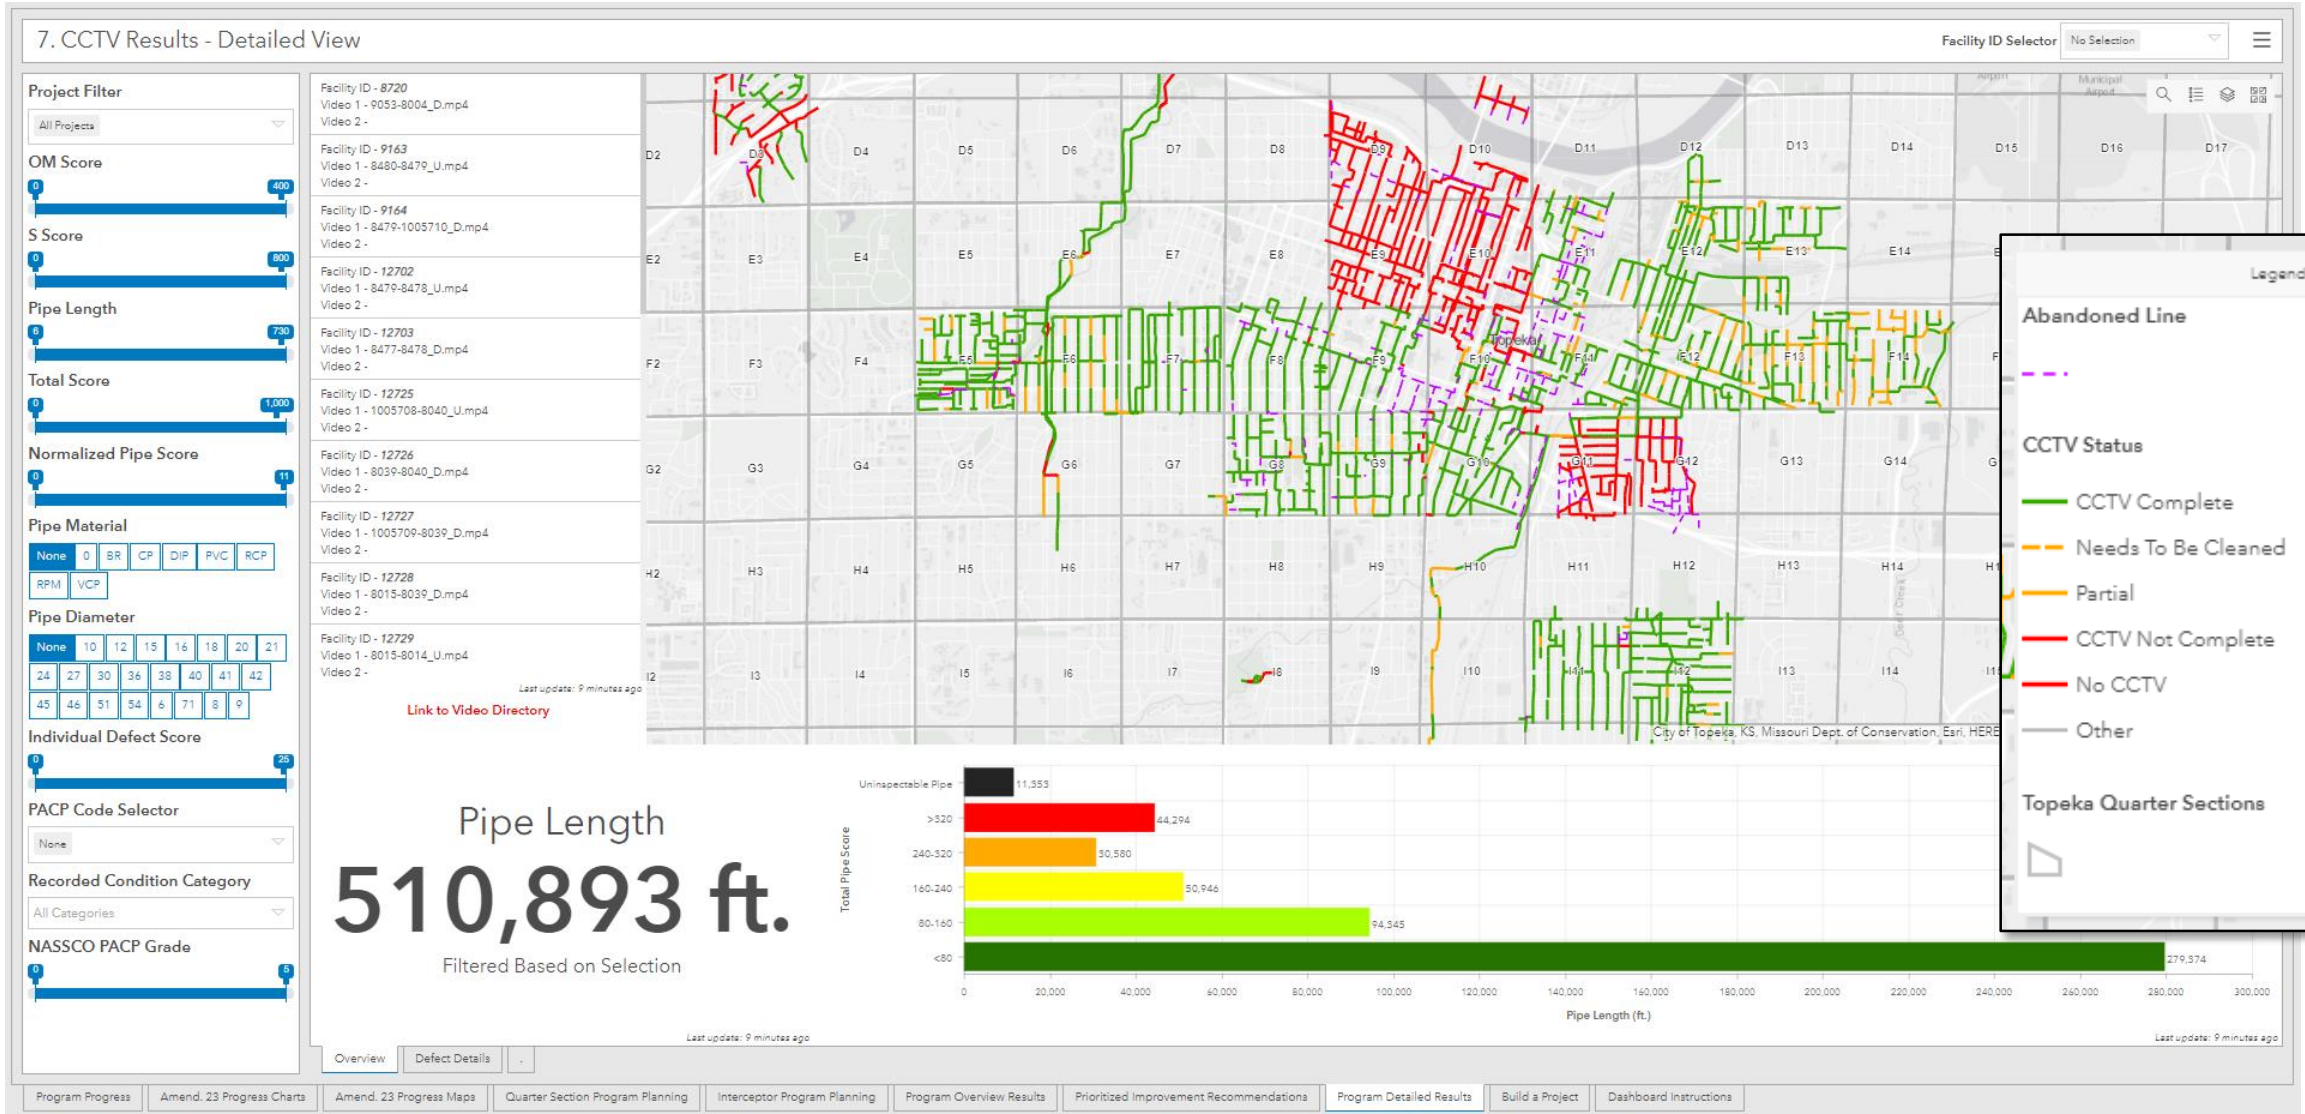
Program Dashboard: Detailed Results – Pipe Condition

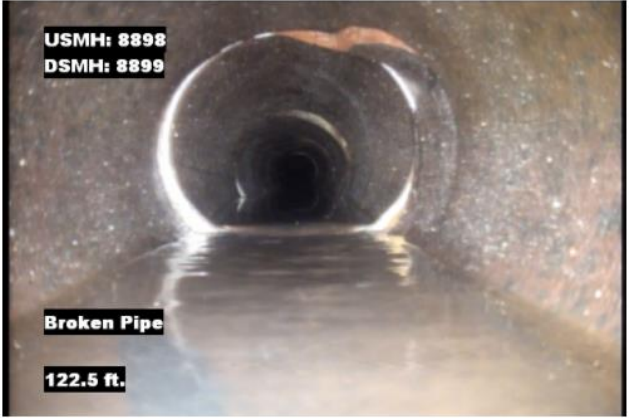
17935_5142019_B_122.5_U.jpg

USMH: 8898
DSMH: 8899

Broken Pipe

122.5 ft.

- Broken (B) - 14 Defect Score - F7**
- Tap Factory Defective (TFD) - 6 Defect Score - F7
- Fracture Multiple (FM) - 6 Defect Score - F7
- Tap Factory Defective (TFD) - 6 Defect Score - F7
