THE TOPEKA LANDMARKS COMMISSION MEETING

A G E N D A

Thursday, January 14, 2021

- I. CLGR20-25 by Sisters of Charity of Leavenworth Health System, Inc., seeking State Preservation Law Review under K.S.A. 75-2724 for the proposed demolition of the Menninger Tower building, located at 5800 SW 6th Avenue. The building is listed on the Register of Historic Kansas Places and the National Register of Historic Places.

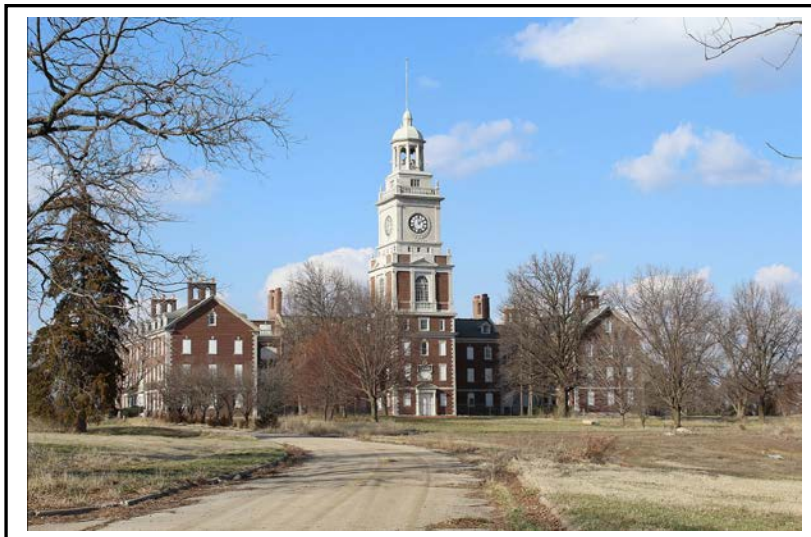
The structure throughout is reinforced concrete except the tower, which is steel frame and concrete floor slab. All walls and partitions are clay tile. The exterior face is English bond red brick. Cornices, first floor coursing, sills, headers, and such architectural details are limestone. Original wood windows remain

(with few exceptions), being 6/6 and 4/4 divided lite sashes.

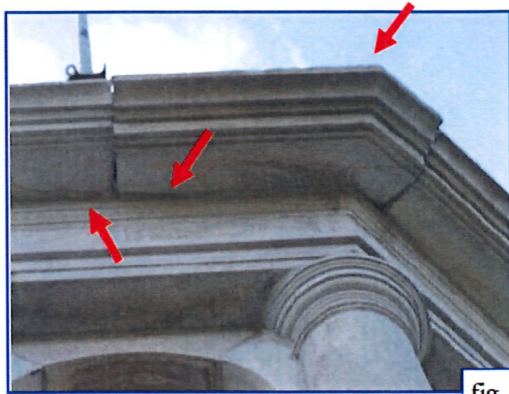
fig. 1

stone back in place and pinning it back together. Both if these options are work that should be done by a specialty contractor that does this type of restoration work. When doing this work the adjacent stone to the north of this stone should be investigated. As seen in figure 1 there appears to be a crack in the bottom of that stone as well. No distress was noted in this stone as the time of our observation.

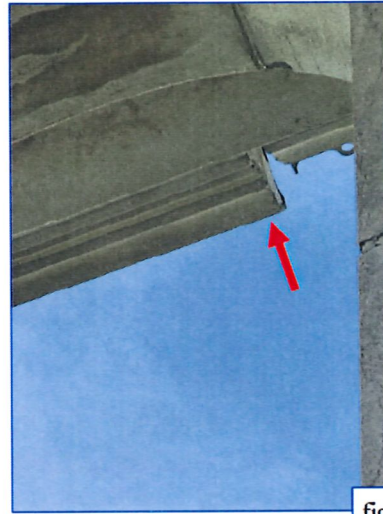
fig. 2

At the time of our site visit a cornice stone on the west side of the lantern was dislodged from the wall and rotating down (fig. 1). Figure 2 shows the stone from inside the lantern. In figure 1 note the crack in the bottom of the stone where the wall and the stone intersect. The top of the stone is shown from the inside of the dome in figure 3. Note the fracture in the stone. The stones bear on the multi-wythe brick walls of the lantern and cantilever out. The top of stone is held in place by a steel channel with its toes pointing up (fig. 4). The stones are anchored to the channel and the channel is attached to the structural steel frame of the dome. This stone appears to have fractured at the exterior face of the wall.

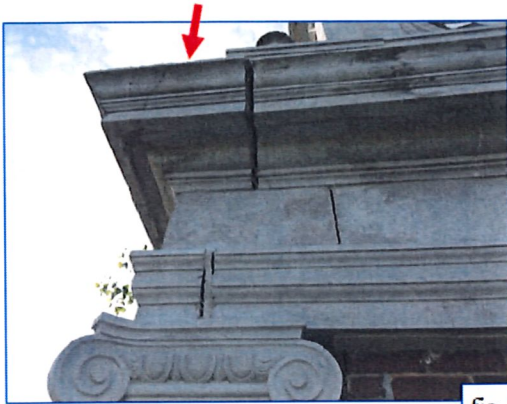
fig. 5

Cursory observations of the tower were made from the manlift. Typical deterioration noted throughout was open stone and brick mortar joints, sealants in mortar joints, failed sealant, spalling stones faces and cracked brick and stone units. The most significant deterioration was taking place in the two stone bands above the arched windows. The corner stones have pushed out (fig. 5) and one stone is moved down slightly (fig. 6). This movement is probably

due to temperature movement and then the effect of freeze thaw. The deterioration noted above is a result of moisture infiltration due to the lack of maintenance over the years.

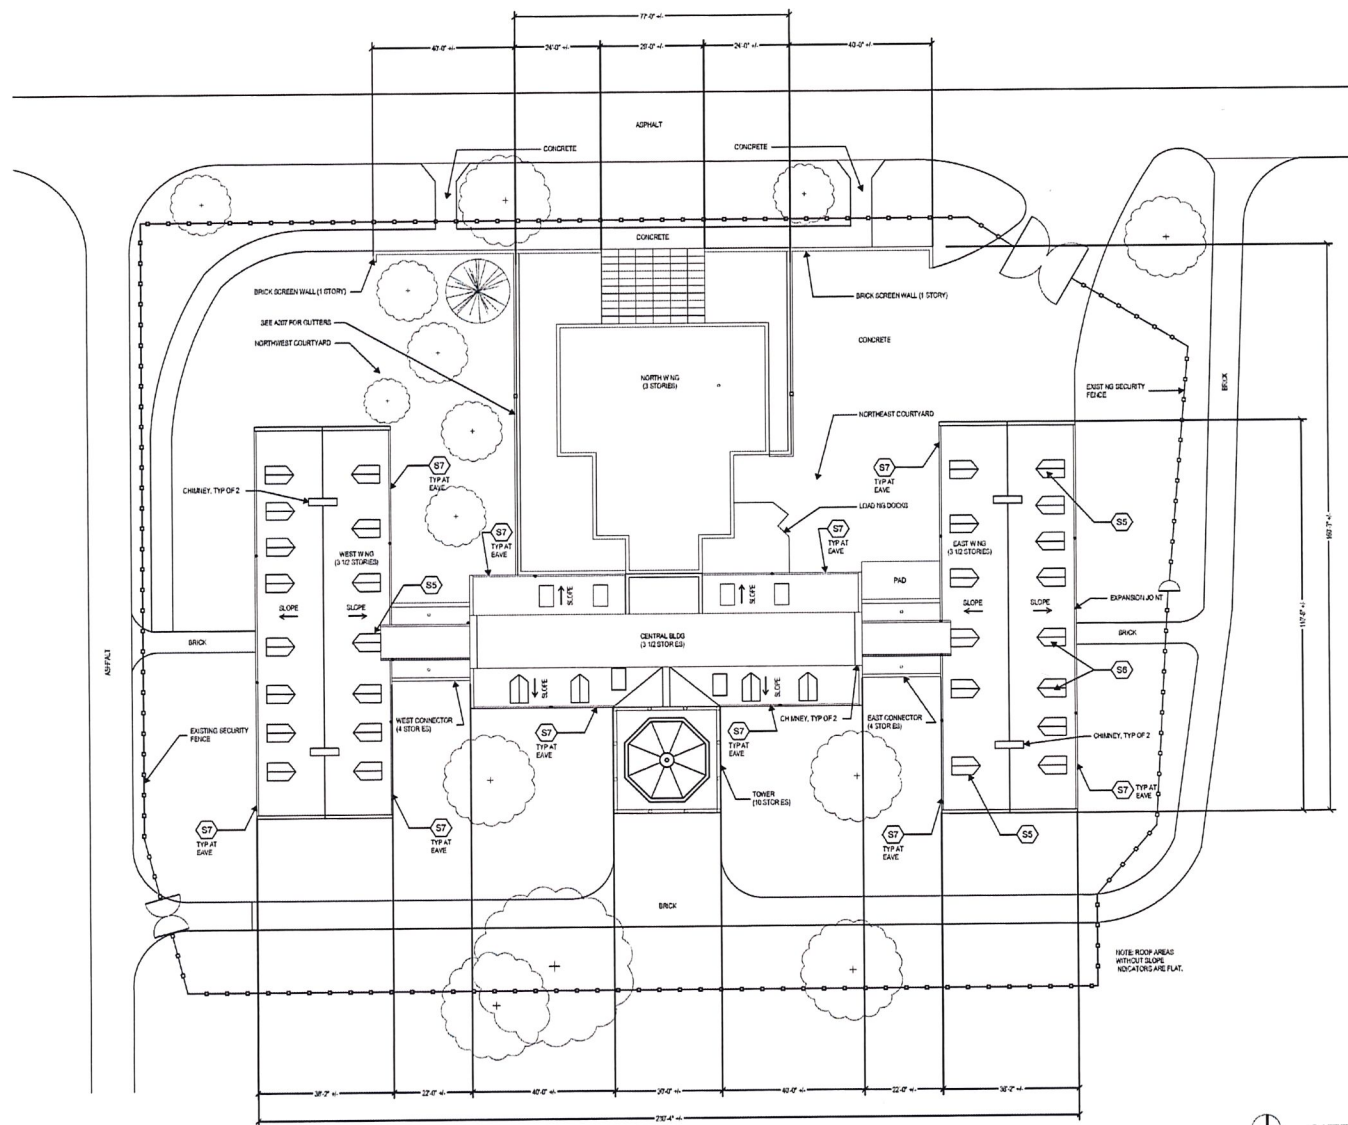
SITE PLAN A1
1/16" = 1'-0"

- ROOF REPAIRS (P1)**
1. CLEAR DEBRIS FROM ALL GUTTERS, REPORT DAMAGE UNCOVERED TO ARCHITECT
 2. SHAPE ALL ROOF DRAINS AND CLEAR DOWNSPUTS
 3. INSTALL STANCHIONS OR STOPPING AT ALL ROOF DRAINS
 4. SEE A300 SHEETS FOR WALL, CHIMNEY, AND DONGER REPAIR
