# Assessment and Feasibility Study for Uptowner Parking Garage

7th and Jackson Streets • Topeka, KS

December 1, 2021

**Photos – November 2, 2021**

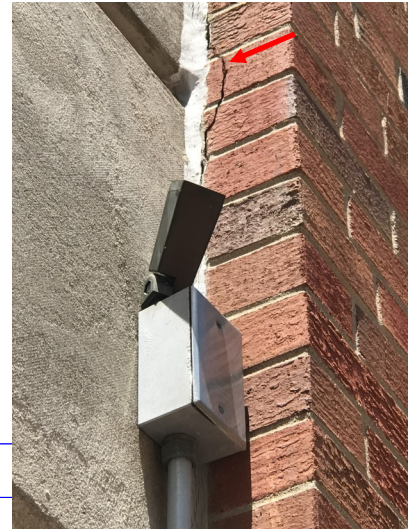
fig. 6

The waterproof membrane installed in the 1982 repair project was not maintained and is worn out. Deterioration was also noted on the exterior of the structure. The first level wall and the stair and elevator tower are clad with brick. These walls contain cracked brick (fig. 6), open mortar joints (fig. 7) and spalled brick faces (fig. 8). Random area of spalled concrete was noted with the area shown in figure 9 being the worst. Sealant at masonry/concrete intersections, around door and window openings and around mechanical openings is all in failed condition (fig. 10). The doors on the north and central stair towers were found in poor condition (fig. 11). The north exterior wall has concrete spandrel beams with concrete masonry unit (CMU) infill. This wall has been coated in the past with an elastomeric coating which is now deteriorating.

The exterior walls require repair and waterproofing to prevent further deterioration. The concrete should be repaired by method described above using SikaQuick-VOH patch material. All cracked brick and brick with spalled faces shall be removed and replaced with matching brick. All cracked and open mortar joints shall be properly prepared for repointing and repointed in 3 lifts of Type N mortar mix in color to match existing. All existing sealant shall be removed and replaced with Sikasil WS-295 sealant. Prepare substrate per manufactures recommendation. Use closed cell backer rod to control depth. The north wall shall be waterproofed by installing new elastomeric coating. Wall shall be prepped as per manufactures recommendations and two coats of Sherwin Williams CF11W0051-Conflex XL Smooth elastomeric coating applied. The west wall of the north stair tower at the top the brick is in very poor condition with most of the brick having spalled faces. This occurs at the top 5'-6 of the wall. This area should be repaired by removing all loose faces of the brick and applying gunite to the surface. The area shall then be coated with elastomeric coating as described above. The source of moisture infiltration from the top of the wall has been eliminated with a recent installation of a new roof. Just below this area is a concrete spandrel beam with a spalled face approximately 2'-6 x 3'-4 as shown figure 9. This spall poses as life safety hazard. This area should be barricaded a distance of 20'-0 minimum all around. It is very important that all of this
